Analysis of the 1952 Crash of the Search and Rescue B-17 in Tull Canyon; by Paul Eisenberg, 2021

The remnants of a B17G Search and Rescue (SAR) aircraft (AF 44-85746A) lie in Tull Canyon in the Buckhorn Wilderness area of Washington's Olympic Mountains. The site, located at 47.85 degrees N latitude and 123.09 degrees W latitude, is visited by many hikers every year.

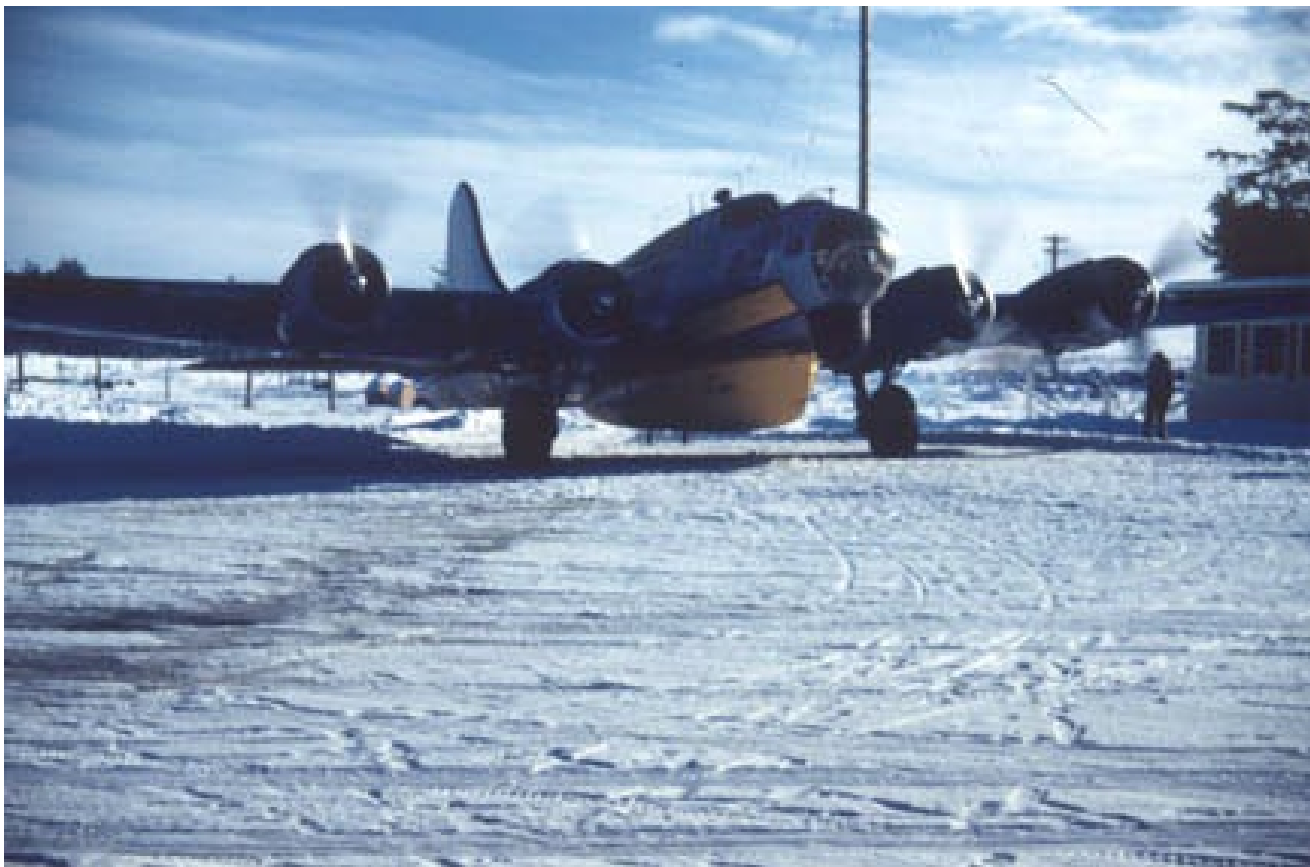
SAR B17G AF 44-85746A warming up at Sandspit prior to its final flight

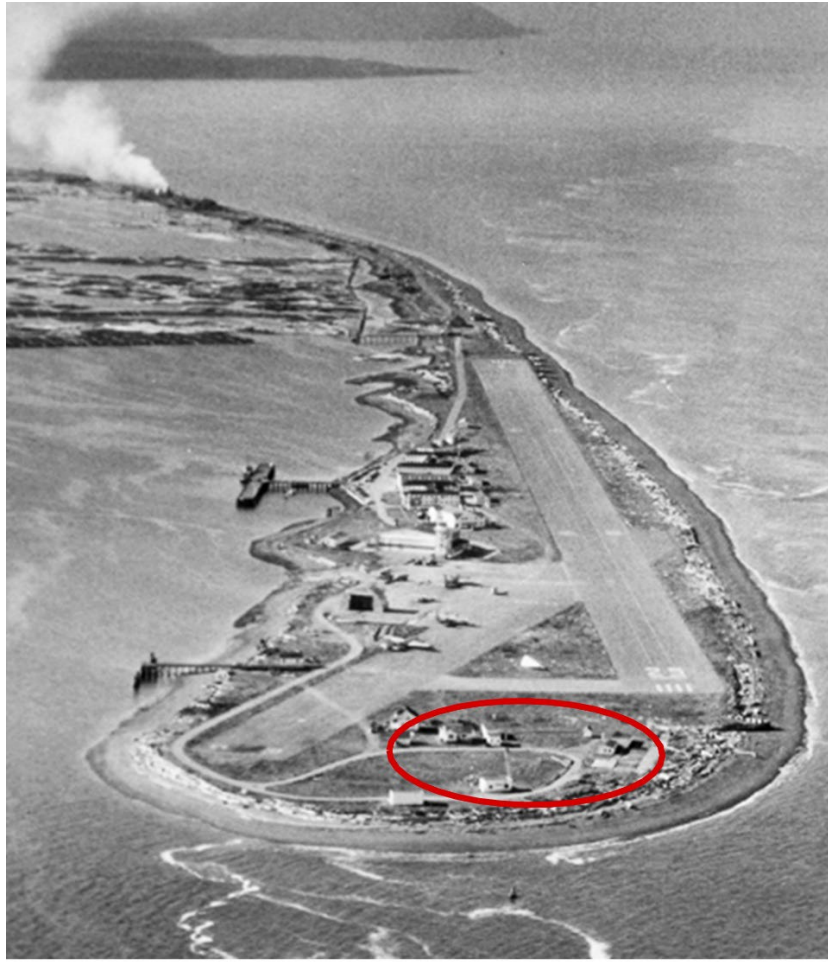
Port Angeles 75 Mhz beacon

My research confirmed that in 1952, in addition to the 75 Mhz intersection marker at Dungeness, there was also a 75 MHz beacon (MRLZ) at the Port Angeles CGAS. See table below from 1952 Federal Register. If they had passed over that 75 Mhz beacon the white marker beacon indicator would have illuminated. The only way to distinguish between these two beacons was by listening to the audio morse code identifiers. The Port Angeles CGAS was located at the end of a long spit, and repeatedly transmitted a Morse code audio identifier of CLM (dah di dah di, di dah di di, dah dah.). The Dungeness fan marker beacon was located at the tip of the Dungeness spit and was co-located at the lighthouse. It transmitted a simple dah dah dah dah. The Port Angeles beacon is 14.2 miles west of Dungeness beacon. Note that the crash site is also approximately 14 miles west of the actual Seattle inbound airway where they should have been.

The answer to the second question is that the white marker beacon indicator would have illuminated at both the Port Angeles CGAS and at Dungeness making it essential to have identified the beacon.

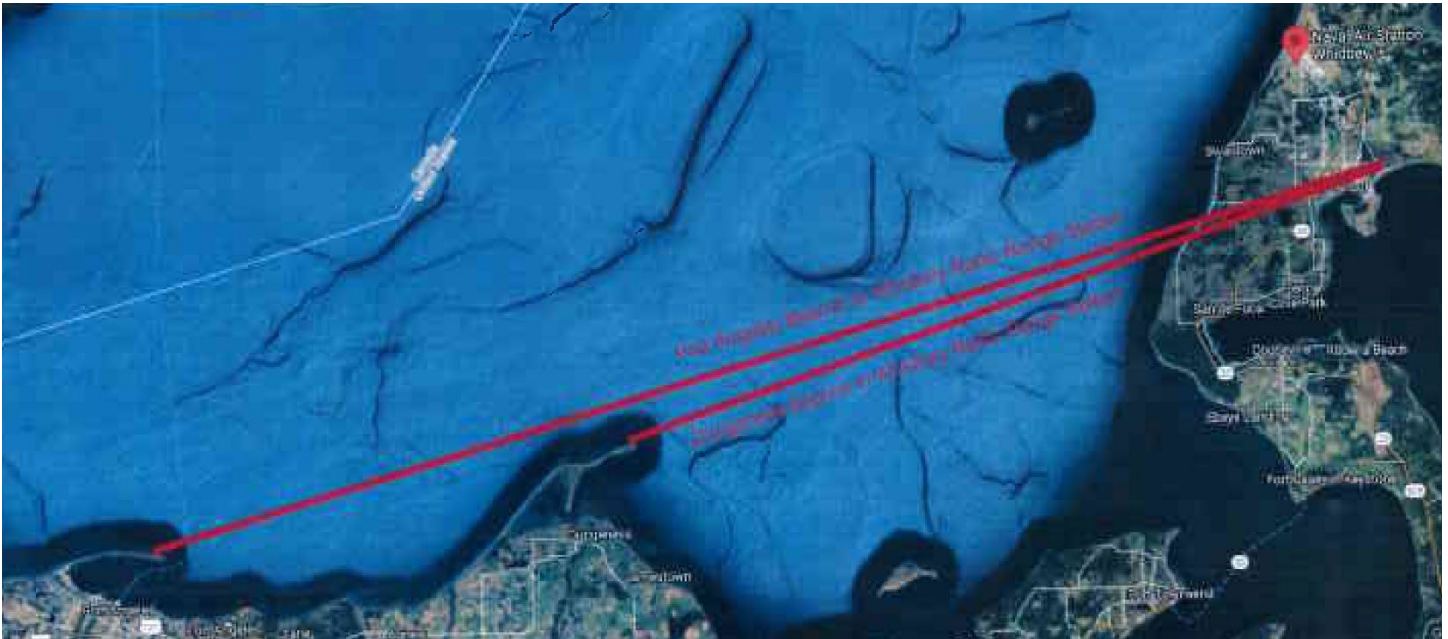
The Radio Range Station at Whidbey was located well south of the actual Whidbey NAS runway, but placed in line with the main runway. Measuring bearings on the WAC chart illustrates that the bearing to the Whidbey NAS Radio Range Station would have been approximately 45 degrees (plus or minus a few degrees) whether measured from either the Port Angeles beacon or the Dungeness beacon. The illustration below shows the exact bearing lines on Google Maps to clearly illustrate the geometry. At the B17's speed of 3 mile per minute over the ground, perpendicular to these bearing lines, the difference in bearings to Whidbey represents less than 10 seconds of flight time. With the equipment in use at that time, on a moving aircraft the difference was not detectable. In effect, those bearing measurements were identical. This bearing gave the crew further false assurance that they were over Dungeness when they were not. In a tragic twist of fate there are only two places on earth where they could have measured a bearing of 45 degrees to the Whidbey Radio Range Station at the same time their 75 MHz beacon light illuminated.

The answer to the third question is that the bearings from the aircraft to the Whidbey Radio Range would have been the same from either Port Angeles CGAS or the Dungeness intersection.

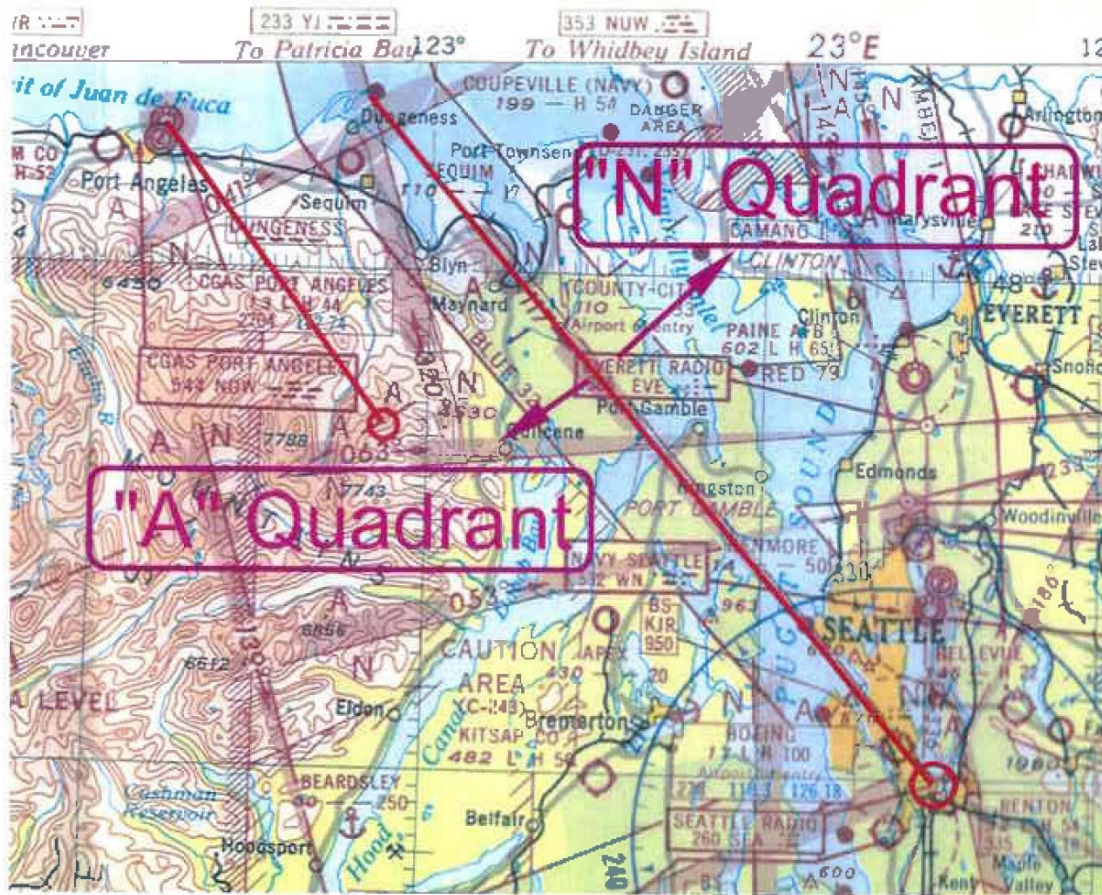
In more detail, at Dungeness the triangle that forms the safe airway would have been 2.6 miles wide. If the aircraft had been off the centerline but within 1.3 miles north of it, they would have heard a strong “N” and fainter “A”. If off the centerline but within 1.3 miles south of the airway, they would have heard a strong “A” and fainter “N” signal. If on the center those would have merged to form a steady tone. The distinct “A” was a

glaring warning that was ignored, because of the confidence placed in the unverified marker beacon, and the useless bearing to the Whidbey Radio Range Station.

The answer to the 4th question is that the “distinct A” the crew reported is fully consistent with the aircraft being over the Port Angeles CGAS. Failing to properly respond to that distinct “A” was the most critical, and fatal error.

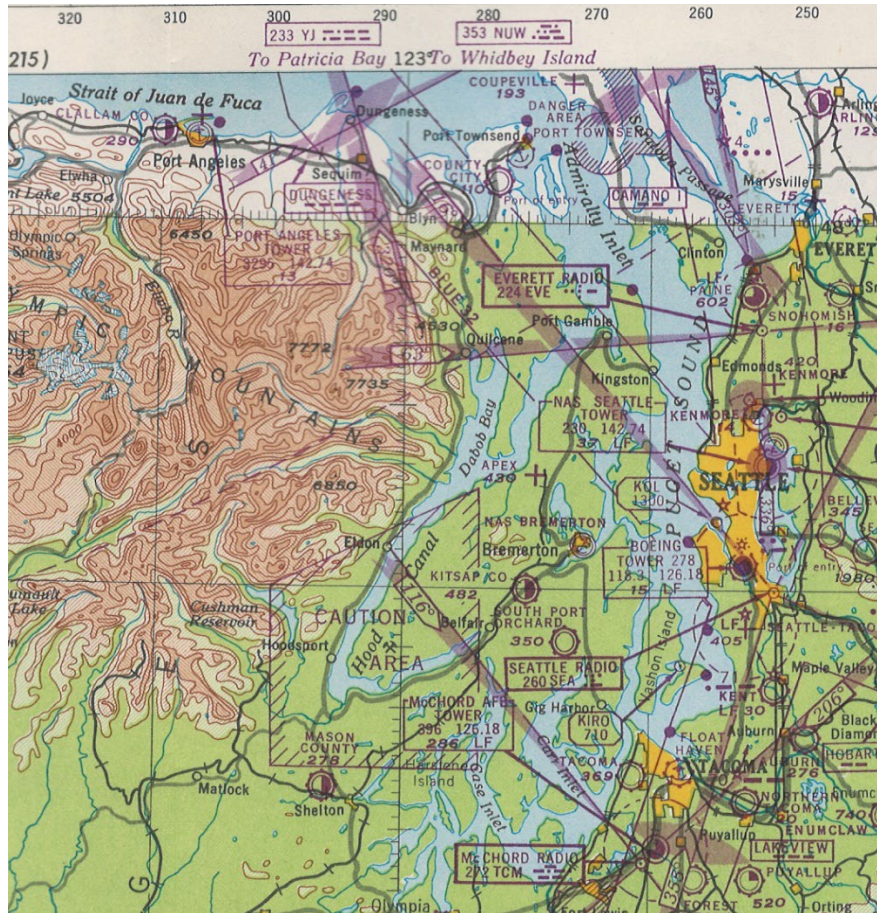
The following chart illustrates the preceding, showing terrain rising above 7,700 feet MSL along a line from the Port Angeles CGAS to Seattle, on the route they flew. Note the orange coloring and spot altitudes. Along a line from the Port Angeles CGAS to Everett the terrain does not rise more than 1,000 feet MSL. Eventually, as

the aircraft flew into the mountains, even the line of sight to Everett became blocked. The low terrain is shown in green from Dungeness and along the actual airway to Seattle. Note how much terrain clearance the aircraft would have had at 6,000 feet MSL had they actually been on the airway (the narrow purple triangle with its tip at Boeing Field.)

The answer to the 5th question is that from Port Angeles at 6,000 feet MSL (and for the following few minutes) the aircraft could have communicated via VHF voice radio with Everett, but could not have communicated with Seattle.

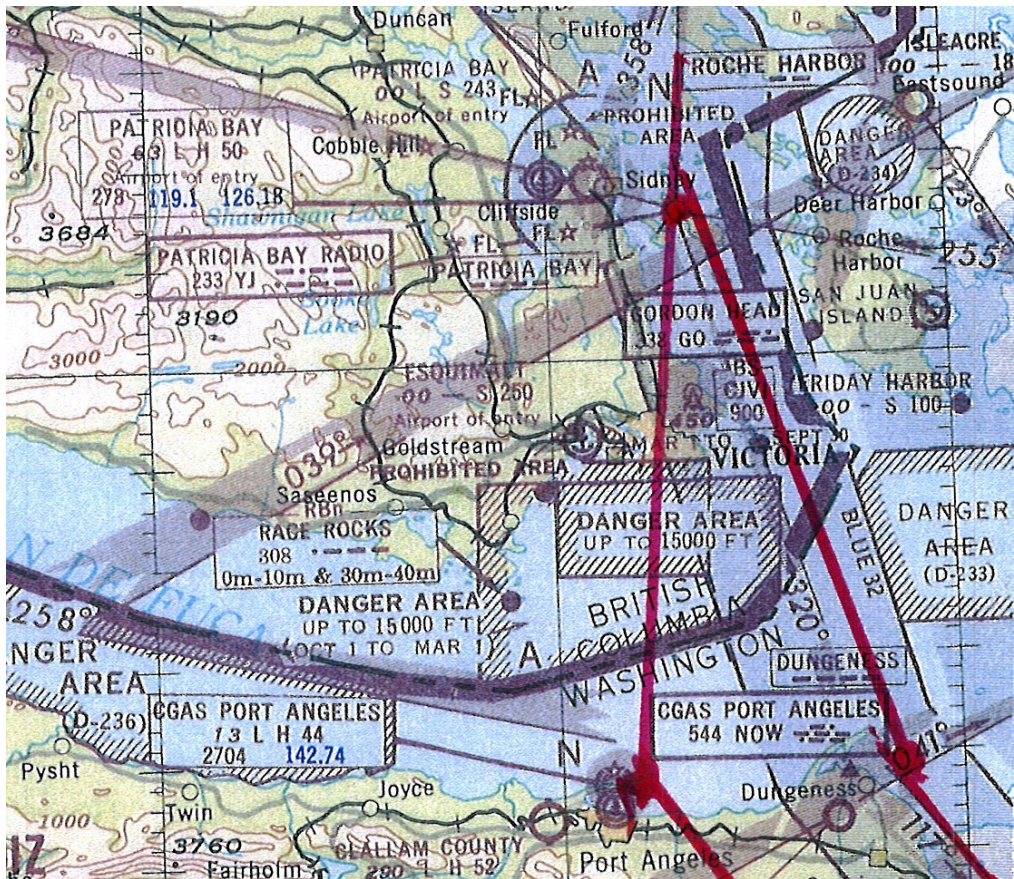
The following illustration shows courses from Patricia Bay to Dungeness and Patricia Bay to Port Angeles CGAS on a 1952 WAC chart. correct airway route from Dungeness to Seattle.

The distance from the Patricia Bay Radio Range Station to either Dungeness or the Port Angeles CGAS is the same; 35 statute miles, which would have taken 11 minutes to either destination.

So the answer to the 6th question is that there was no difference in the time from passage over Patricia Bay to either the Dungeness marker beacon or the Port Angeles CGAS marker beacon. At either location the marker would have illuminated at the expected time if they had been on the actual airway.
